PROGRAM TRANSFER & REQUALIFICATION · MAJOR APPLIANCE OEM

# Anyone can inherit the equipment. Very few suppliers will inherit the responsibility.

A major appliance OEM's incumbent exited three UL product lines. RELY took over the tooling and rebuilt the manufacturing system underneath it.

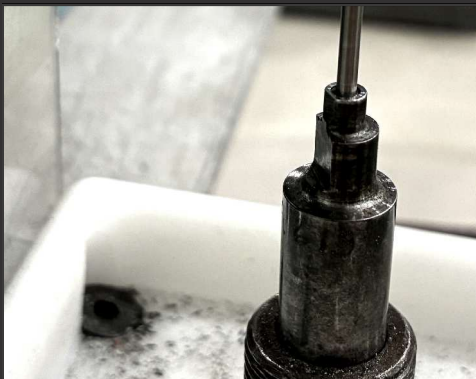
INHERITED CUSTOM ANVIL  
FAILED ON FIRST PRODUCTION ORDER

- The already-overdue first order began, and the **inherited custom anvil failed**.
- Spare tooling included anvils with broken tips, and others built for different rivets.

The spare-parts box told part of the program's history  
**the transfer documentation didn't.**

Broken spare anvils suggested this wasn't the program's first tooling failure.

### Friday 11 AM to Monday shipment – the recovery, hour by hour.

| Damaged tooling arrives back at RELY. Recovery begins. | Customer flags a shortage one week out. <b>RELY gets an outside machine shop to reopen after hours.</b> | <b>Bridge fix produces the first good parts.</b> | Bridge solution fails. Team immediately develops a second fix. | <b>400 parts finished and shipped that same day.</b> |

AFTER SHIPMENT · PERMANENT CORRECTIVE ACTION **Three replacement anvils ordered.**
